# Manhole Inspection Summary

Manhole # S2701\_014MH

Insp Date: **3/10/08 9:06 AM**

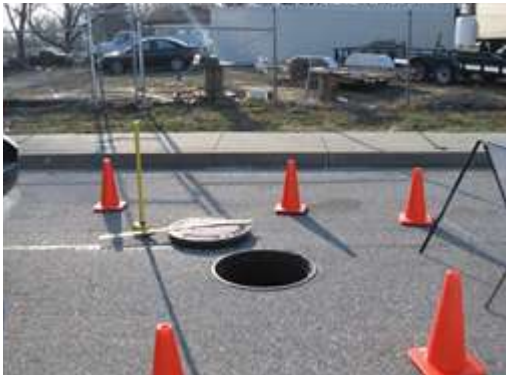
Location View

3300 Magnolia Ave.

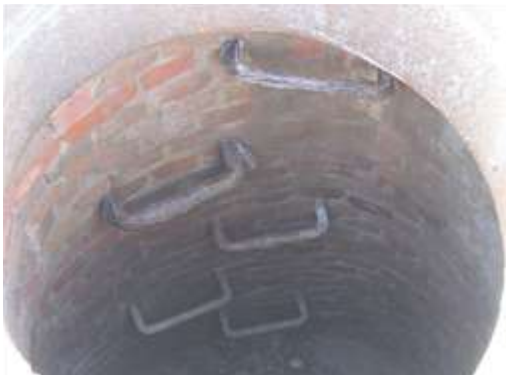
Steps

**Steps** Count: **5** Missing: **0** ☒ Corroded

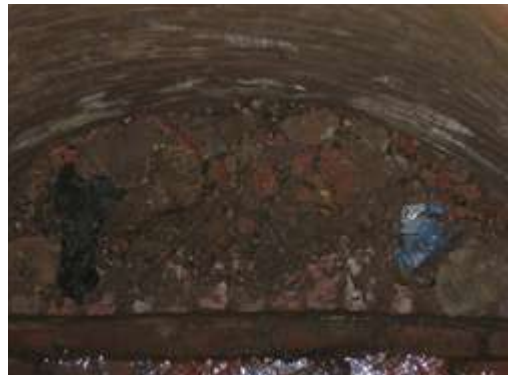
Defect 1

Condition: ☐ Sound ☐ Cracked ☐ Root Intrusion ☐ Deteriorated ☐ Leaks ☒ Debris

Debris

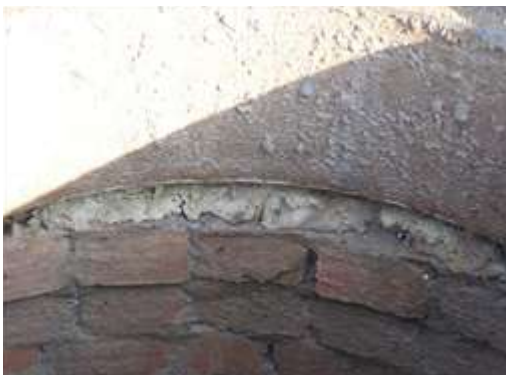
Defect 2

Infiltration: ☐ None ☐ Joint ☐ Cracks ☒ Mortar ☐ Roots ☐ Wall

Infiltration

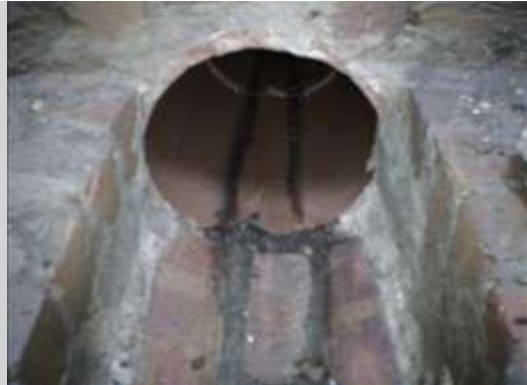
12 O'Clock Outflow

8 in. Circular Gravity Sewer  
Pipe Out @ 12 O'Clock

Pipe Height: **8.4** (in.) Rod and Bar (Angled)  
Pipe Material: **Clay** ☐ Pipe Lined  
Invert Depth: **8.18** (ft.) Flow Characteristics: **Fast**  
Deposits: ☒ None ☐ Mud ☐ Sludge ☐ Debris ☐ Grease  
Silt Depth: (in.) Deposits Extent:  
Infiltration: **None** Pipe Seal Cond: **Sound**

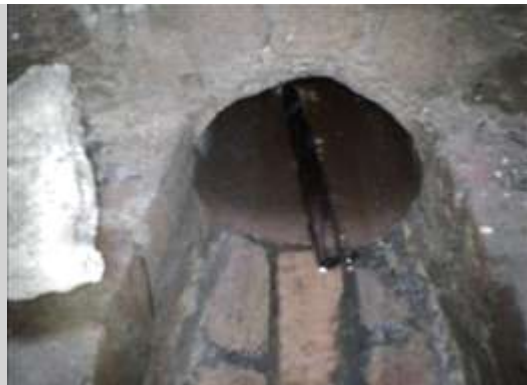
6 O'Clock Inflow

8 in. Circular Gravity Sewer  
Pipe In @ 6 O'Clock

Pipe Height: **8.4** (in.) Rod and Bar (Angled)  
Pipe Material: **Clay** ☐ Pipe Lined  
Invert Depth: **7.99** (ft.) Flow Characteristics: **Fast**  
Deposits: ☒ None ☐ Mud ☐ Sludge ☐ Debris ☐ Grease  
Silt Depth: (in.) Deposits Extent:  
Infiltration: **None** Pipe Seal Cond: **Sound**
